MCCOY-LINN DAM STREAM RESTORATION PROJECT SPRING AND BOGGS TOWNSHIPS, CENTRE COUNTY, PA

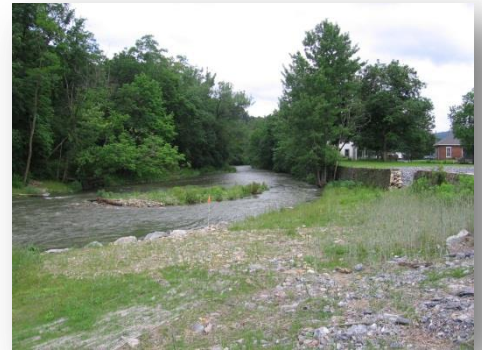
BEFORE

The McCoy-Linn Dam was removed to allow for fish passage throughout the lower reaches of Spring Creek, a high-quality cold water fishery. Once the dam was removed, remnant sediments remained on the banks and the creek flowed through a constricted channel. The stream had high water velocities throughout the reach as a result of the narrow channel. Erosive conditions existed throughout the reach due to the high water velocity, contributing sediments into the Spring Creek watershed. The Pennsylvania Fish and Boat Commission and a not-for-profit organization retained WHM to

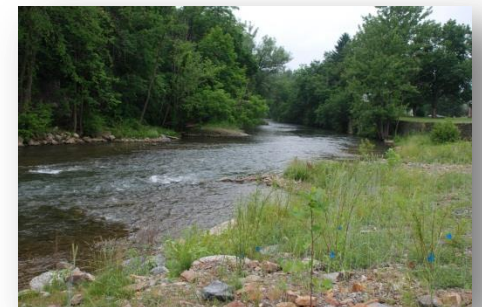
AFTER

An improved aquatic and riparian habitat exists at the former dam location. The healthy stream reach not only benefits aquatic and terrestrial species, but increases the recreational opportunities throughout for anglers and boaters alike. WHM was able to complete all necessary measures for this project quickly in order to fulfill the client's needs to reconstruct this portion of Spring Creek.
